# CARPENTER BEE SIGNS & DAMAGE

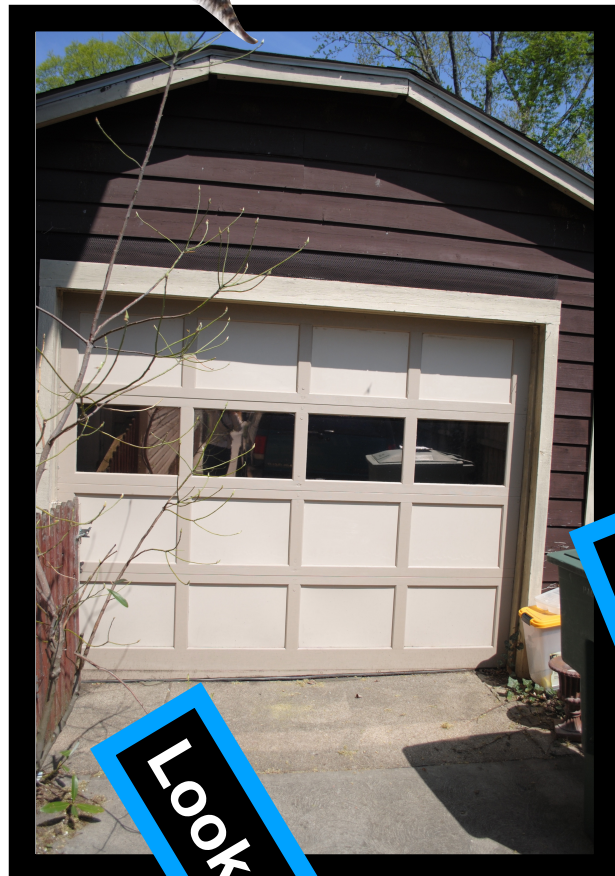
Look UP

**"Kick Back"**- looks like someone took a paintbrush and flicked it against building. It's the chewed wood that the bees kick out to make their nest.

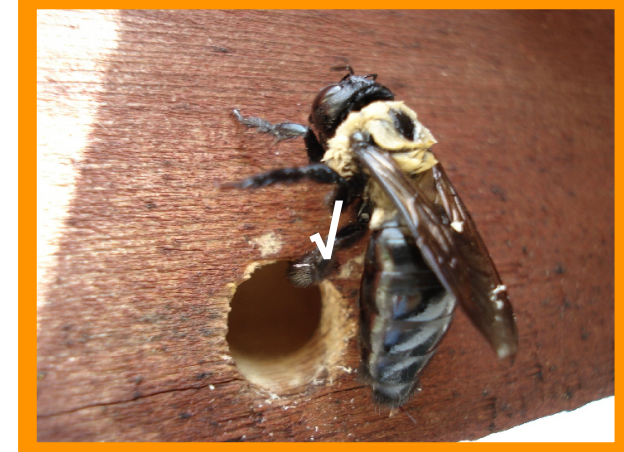
**Nest** - Perfectly round holes, a little bigger than a pencil diameter, will be visible behind the fascia board along the roof line.

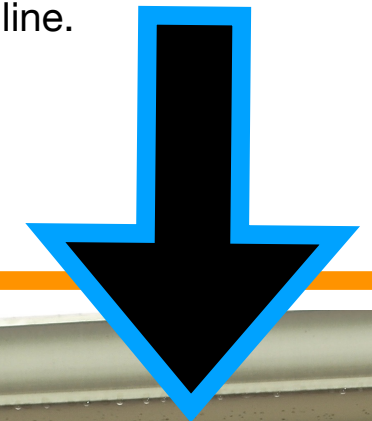
Look DOWN

**Frass** - the wood shavings from the hole the bees made for their nest, that will be in a pile below.

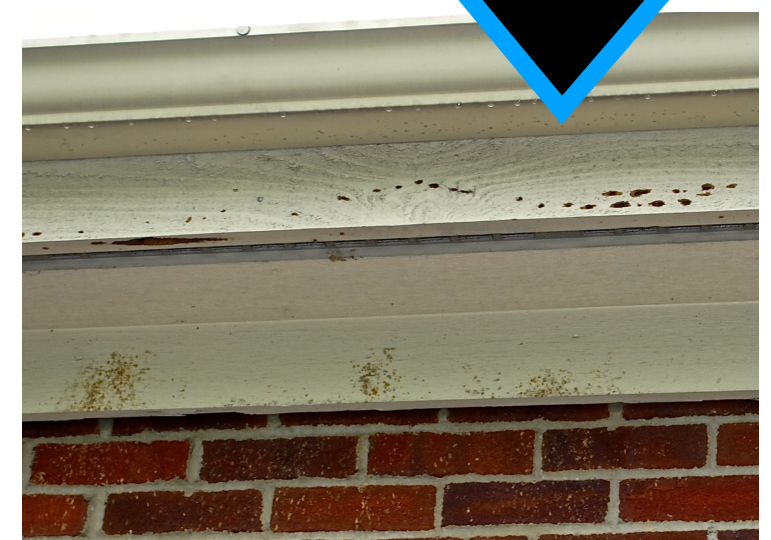
If you see a visible carpenter bee nest, along with this visible damage in same area, it indicates a **wood pecker** was there chipping away trying to get at the eggs in the nest.
